Big Pipe Restores Function to Levee, Protects Florida Wetlands

St. Johns River Water Management District, Fellsmere, FL

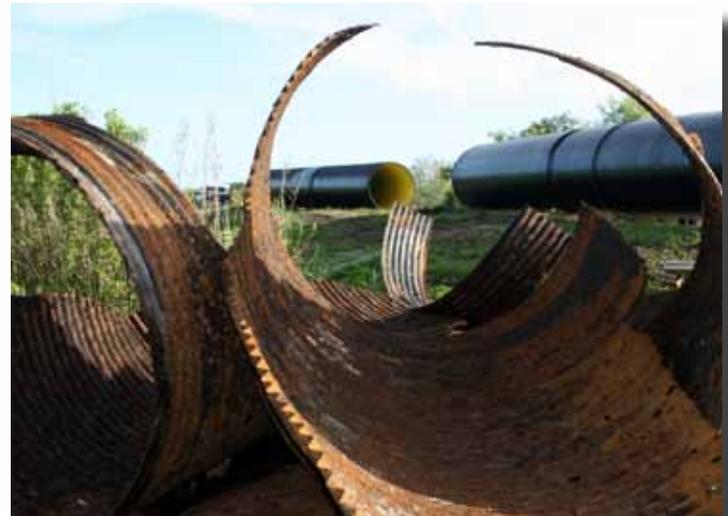
Located along the St. Johns River on country road 512 in Fellsmere, Florida, levee S-251 was badly deteriorated due to corrosion. If left unrepaired, the structure would become inoperable. A drought exposed four damaged drainage culverts contained within the levee. Each of these culverts was 72 inches in diameter. The St. Johns River Water Management District contracted with Stanley Consultants to perform a diving inspection to determine the condition of the culverts. All four were badly corroded with numerous holes in the pipe, which threatened the wetland ecology.

A view of the excavated deteriorated corrugated metal pipes with the new profile wall pipe liner in the background.

The material chosen to reline the pipe was 60-inch diameter ProCor profile wall pipe manufactured by Profile Pipe Technologies (PPT) and supplied by ISCO Industries.

The pipe underneath the levee was in poor shape up to about five feet from the gate where it had completely worn out. Shaune Rogers, one of Shenandoah’s divers, had earlier excavated and removed the parts that had completely failed. In the sections where there was no old pipe, the new profile wall pipe extended past the culvert close to the gate.

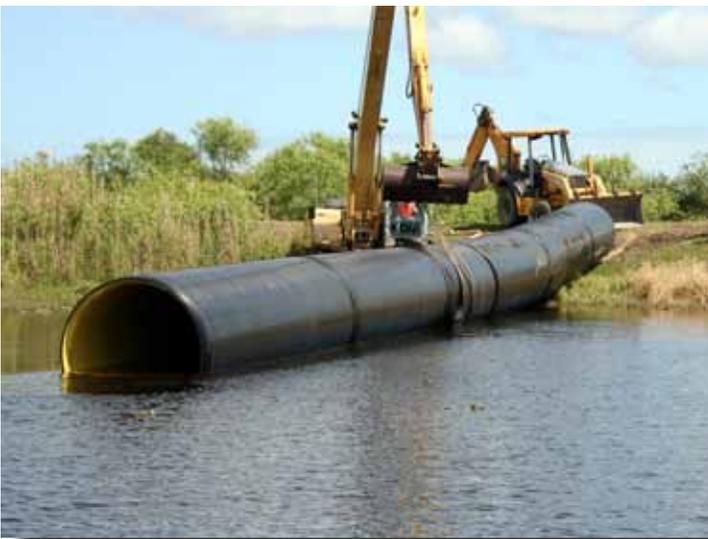
The electrofused PPT pipe was placed in the water to be submerged under water and pushed into the old pipe.

The PPT profile wall pipe, once it was fused and tested, was placed into the water with the aid of two of Shenandoah’s divers. The divers then helped guide and submerge the pipe underwater.

The divers pushed and slipped the new pipe into the old pipe, stopping short of the flood gates.
